SECTION IV - ASSESSMENT OF EXISTING ARCHITECTURAL CONDITIONS & RECOMMENDED REPAIR WORK

Preservation Plan

First Unitarian Society of Plainfield

724 Park Avenue
Plainfield, New Jersey 07060

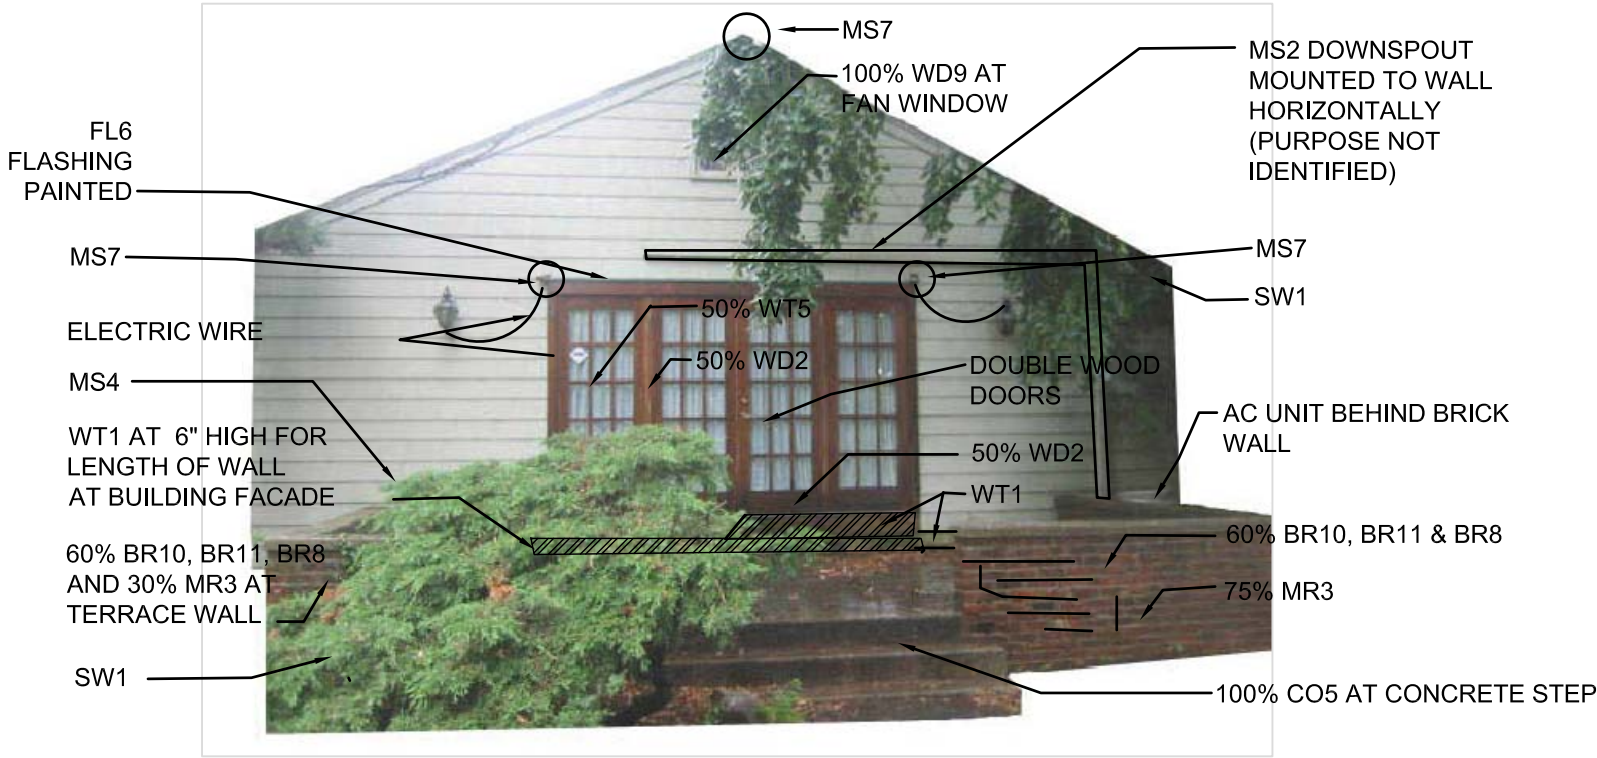
1 NORTH ELEVATION
A-4.04 STEVENS WING-STEVENS ROOM

NOTES:
FL1 - CLEANOUT, UNBLOCK AND REPAIR OR REPLACE ALL GUTTERS AND DOWNSPOUTS (100%)
SW4 AND SW5 - THE GRADE ALONG THE EAST SIDE OF THE STEVENS WING HAS SEVERE PROBLEMS WITH DRAINAGE AND PLANT GROWTH. REMOVE ALL PLANT MATERIAL AND REGRADE AREA (100%).
ROOFS - REFER TO DRAWING A-4.20 FOR ROOF CONDITIONS

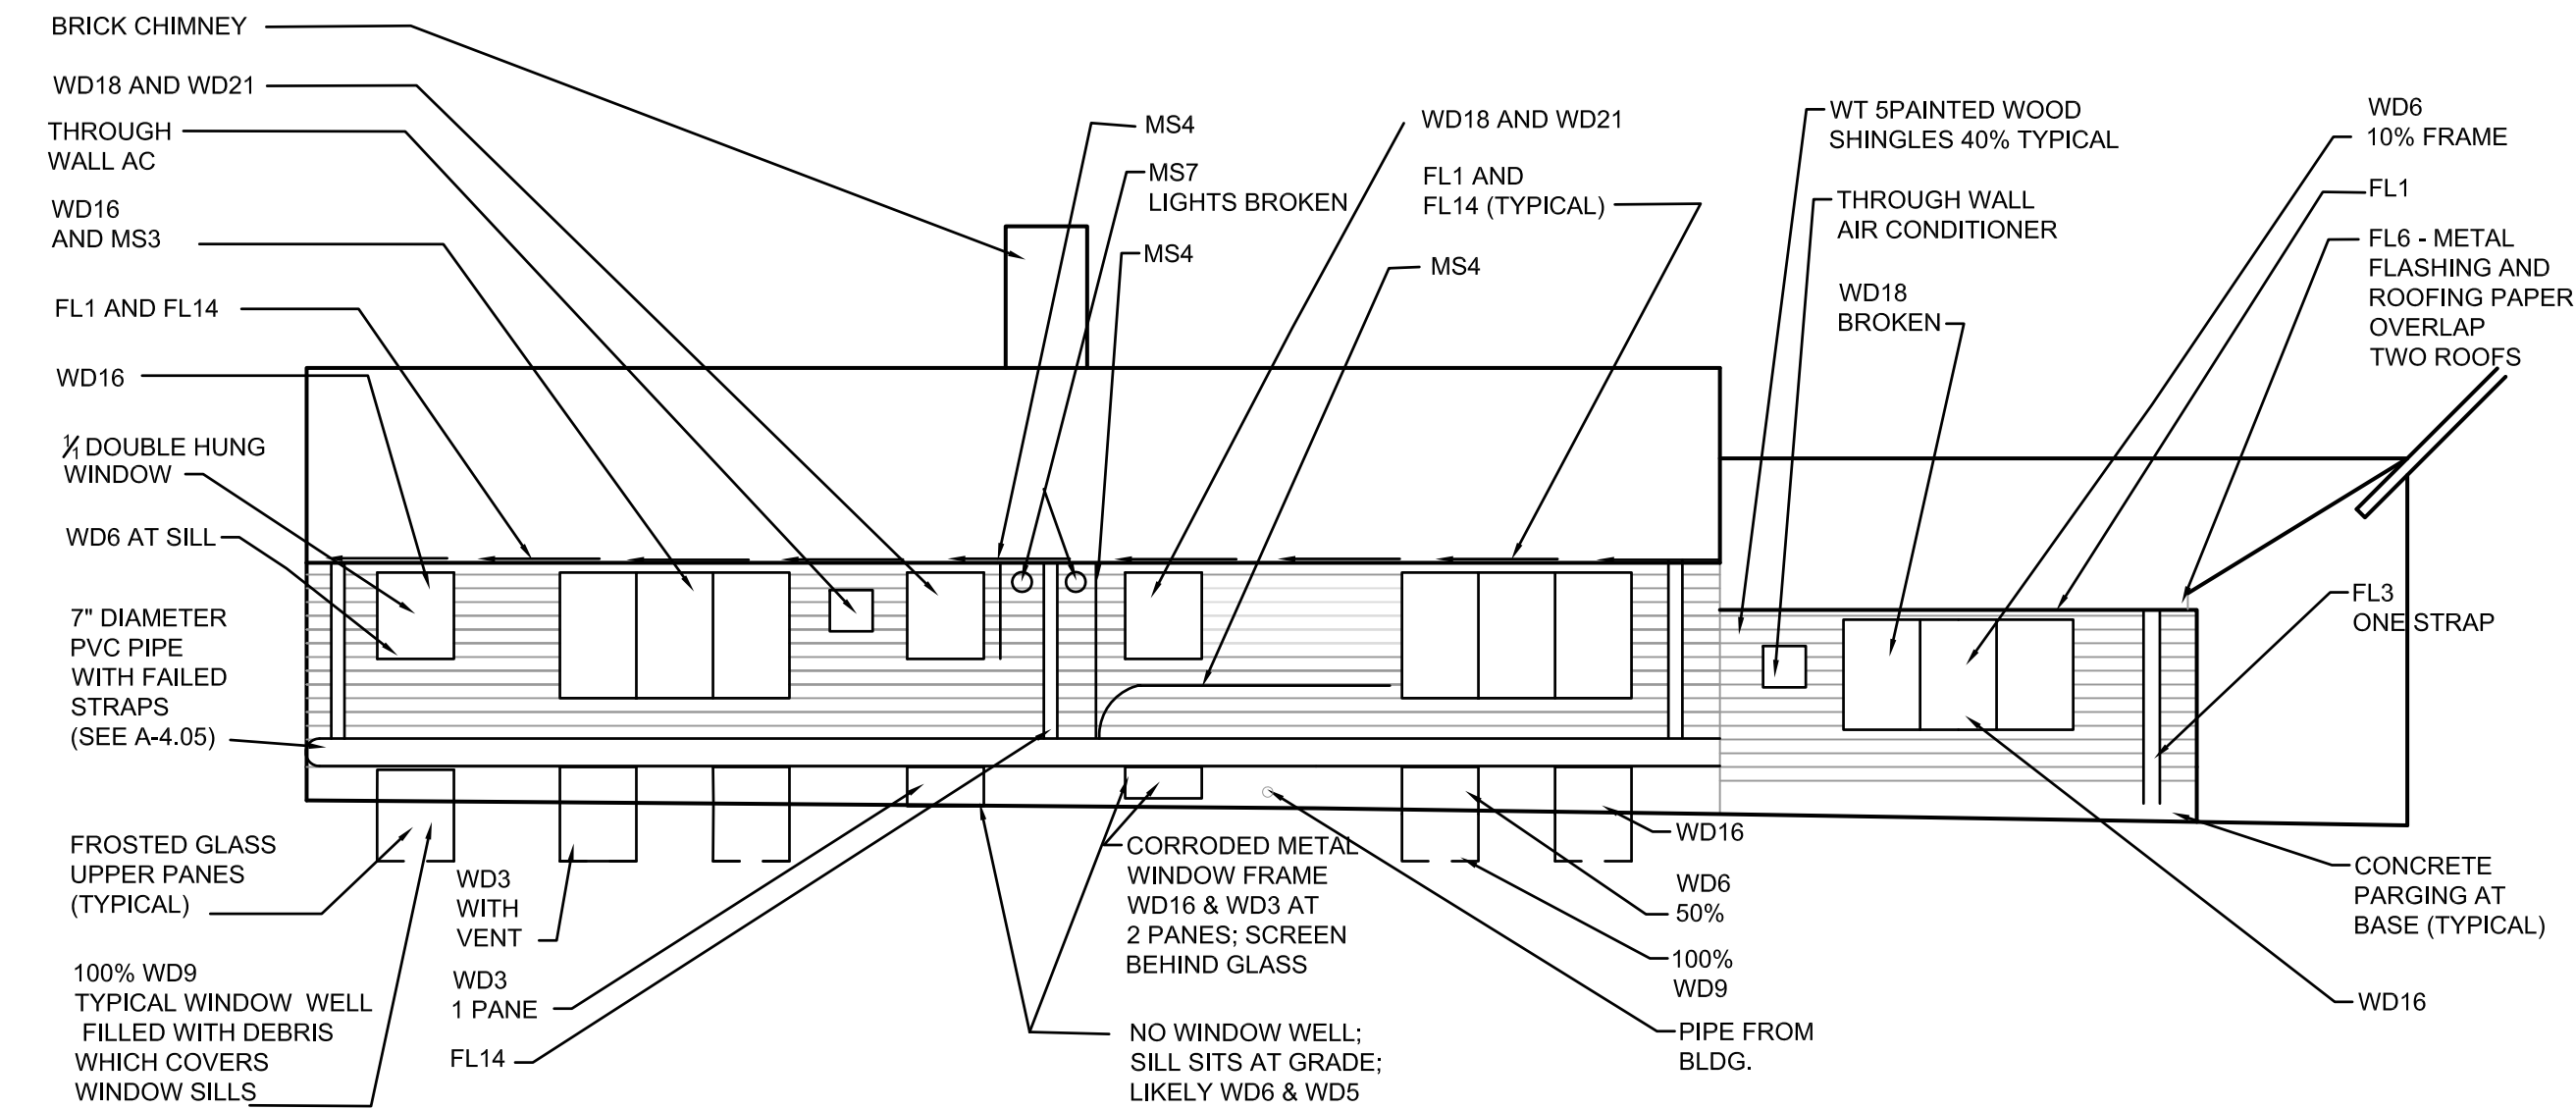
1 WEST ELEVATION - STEVENS WING
SEE ALSO 1
A-4.06 A-4.05

NOTES:
SW4 THROUGHOUT THIS ENTIRE AREA . REMOVE PLANT MATERIAL, ROOTS, STUMPS AND DEBRIS AND REGRADE AREA. (100%).
FL1 -CLEANOUT, UNBLOCK AND REPAIR OR REPLACE ALL GUTTERS AND DOWNSPOUTS (100%)
FOR ROOF NOTES SEE DRAWING A-4.20.
